## Low altitude multispectral mapping for road defect detection

Shahrul Nizan Abd Mukti<sup>1</sup>, Khairul Nizam Tahar<sup>2</sup>

### Abstract

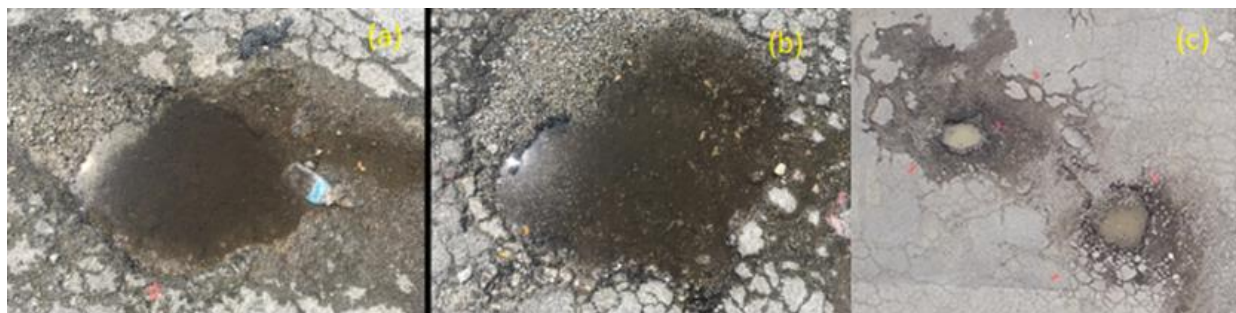
**Figure 3.** (a) Potholes A (b) pothole B and (c) aerial image for both potholes.

A pothole is defined as a bowl-shaped depression in the pavement surface and the minimum plan dimension is 150 mm (Chen et al., 2020). In situ inspection on the road found two potholes around the map area, identified as pothole A and B (Figure 3). Both potholes were measured and the area was calculated for analysis purposes. This area was chosen due to the bad conditions of the road surface. Parking areas were used for buses and other heavy vehicles which operated for the students' public transportation. Lack of maintenance caused the condition of asphalt tear, and allowed water to break through it. In time the crack spread and became a pothole.

Both potholes recorded 5 cm in depth and the maximum pothole length was 1 m. The Parrot Sequoia Sensor was used for detection purposes. However, a multispectral sensor was specifically used for farming/agriculture purposes. The Parrot Sequoia Sensor was designed to suit any type of drone. Thus, it is important to know the significant band on pothole features. Parrot Sequoia is specifically used in the agricultural fields with several spectral bands which measured the state of the vegetation: Green (550 nm wavelength, 40 nm bandwidth), Red (660 nm wavelength, 40 nm bandwidth), Red Edge (735 nm wavelength, 10 nm bandwidth), and Near-Infrared (790 nm wavelength, 40 nm bandwidth). In this study, the Parrot Sequoia Sensor was attached to DJI Phantom 4 to capture the images. Figure 4 illustrates the integration system between the Parrot Sequoia and Phantom 4 multirotor. Table 1 describes the multispectral sensor specification used for this study.

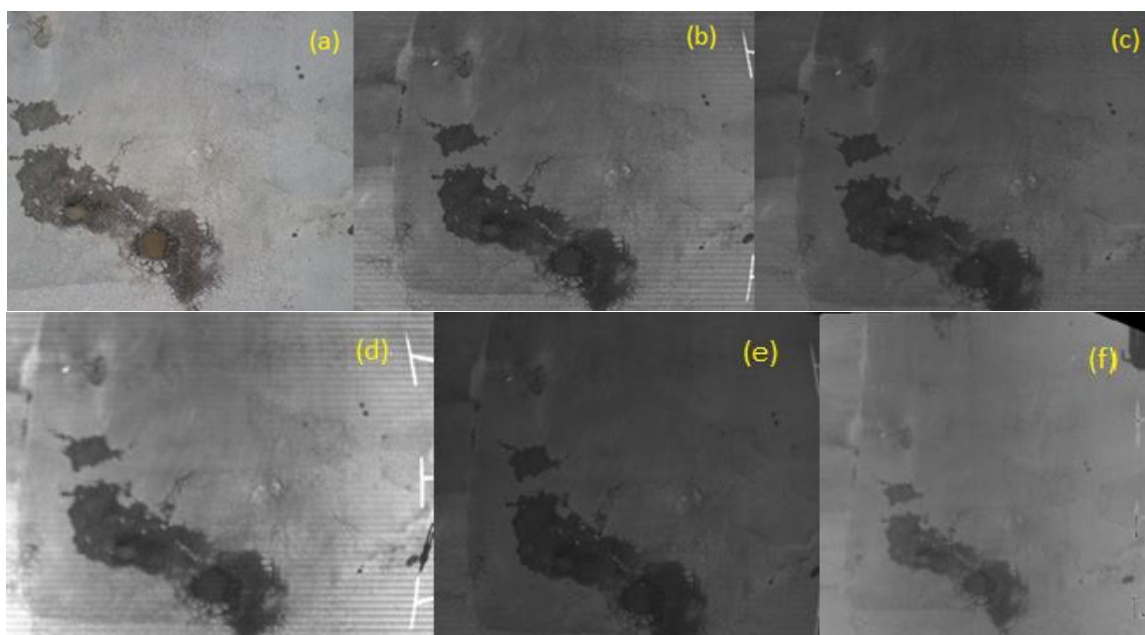
**Figure 5.** Multispectral Images (a) RGB; (b) Near-infrared; (c) Red-edge; (d) Red; (e) Green; (f) Orthophoto of reflectance map.

The example of multispectral images from this sensor is illustrated in Figure 5. Figure 5a shows the RGB image with a resolution of about 16 megapixel, Figure 5b shows the near-infrared band image with 790 nm wavelength and 40 nm bandwidth with 1.2 megapixel resolution, Figure 5c shows the red edge band image with 735 nm wavelength and 10 nm bandwidth with 1.2 mega pixel resolution, Figure 5d shows the red band image with 660 nm wavelength and 40 nm bandwidth with 1.2 mega pixel resolution, Figure 5e shows the green band image with 550 nm wavelength and 40 nm bandwidth with 1.2 mega pixel resolution, and Figure 5f shows the orthophoto of reflectance image.

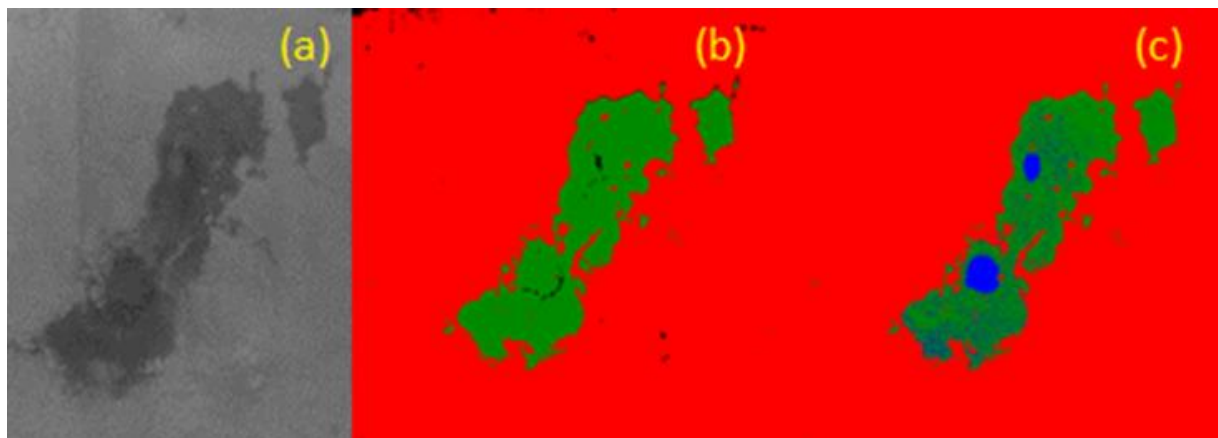
**Figure 6.** a) Orthophoto multispectral (b) classification of asphalt (red) and wet asphalt (green)(c) classification of pothole in blue colour.

Detection of pothole were carried out by classification of multispectral image. A classified area of potholes was exported out for analysis purposes. Before carrying out a spatial analysis, some classifier and combination bands were opted out, because they're failed to detect a pothole. Assessment performance based from the visual condition of potholes, as shown in Figure 6. Figure 6a shows an orthophoto image and Figure 6b shows an undetected pothole from classifier and band combination use. While, Figure 6c shows a successful classification on a pothole.

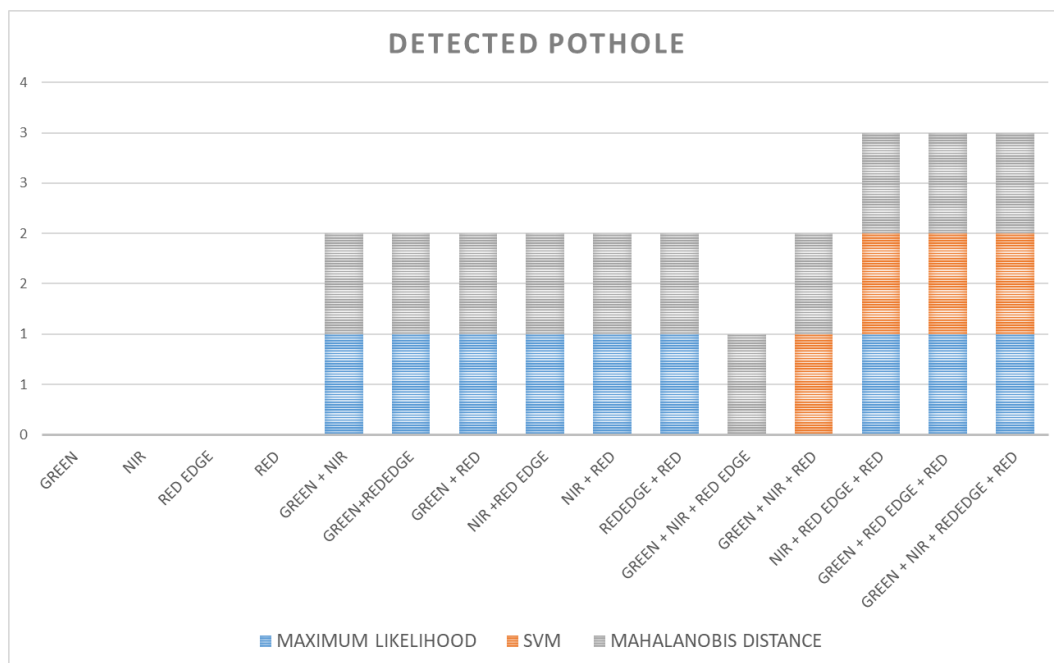
**Figure 7.** Performance of classifier algorithm and band combination to the detected pothole.

Only 24 results acquired a good visual of classified pothole out of 45 results consist from 3 classifier algorithms and 15 band combinations. The analysis referred to the band combination and classifiers algorithm used in pothole detection. Figure 7 shows an error of detected pothole area. All classifier fails to detect a pothole with single band classification. At least 2 classifier algorithms success to detect a pothole with double band and triple band classification.

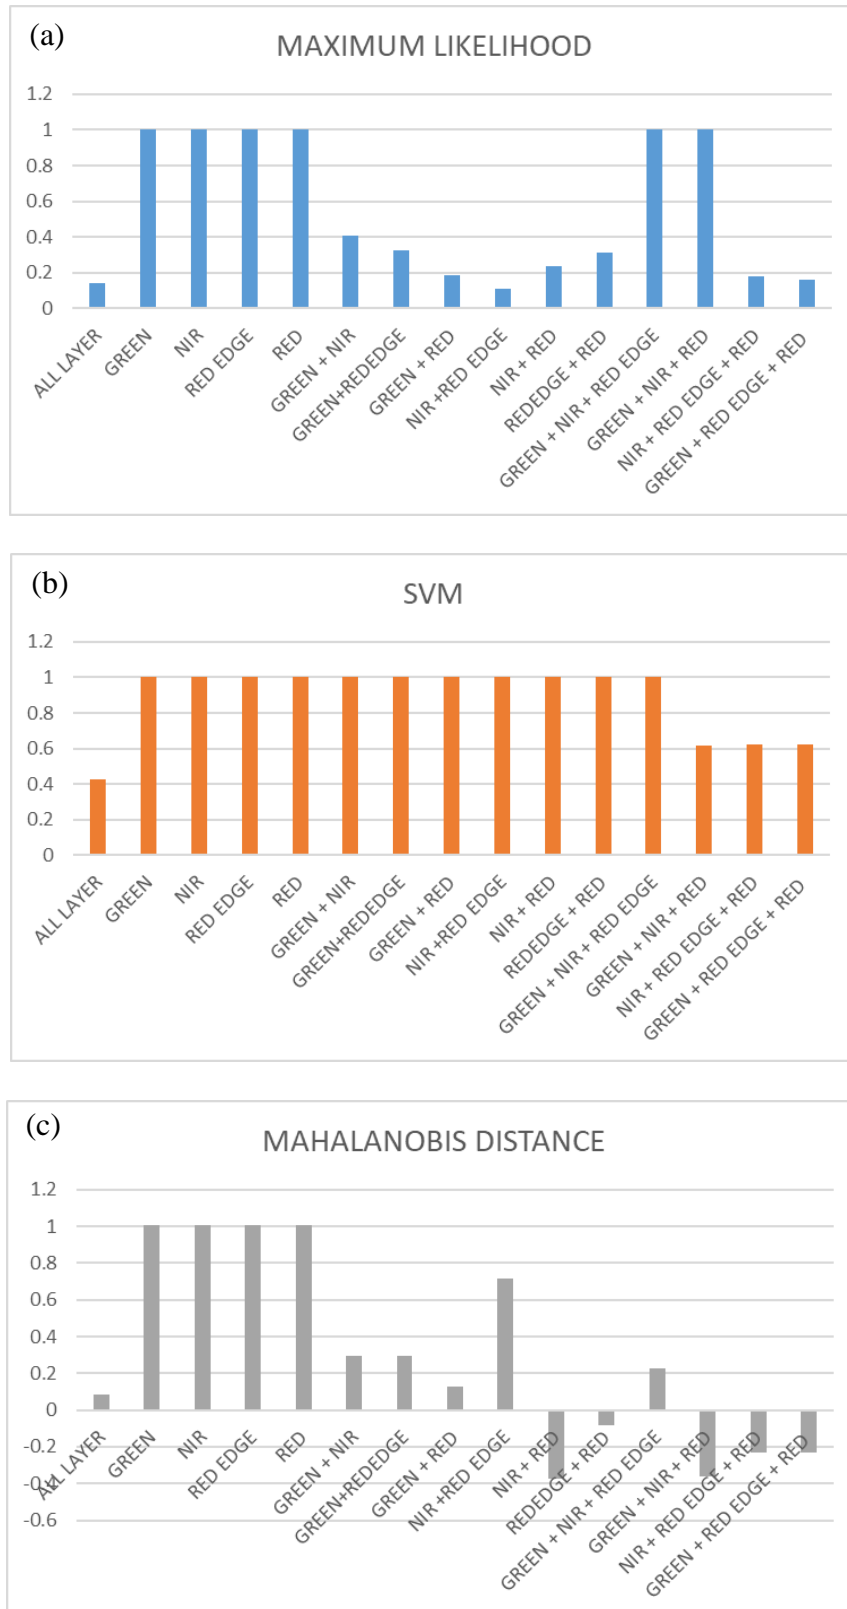
**Figure 8.** Detected pothole area error with (a) maximum likelihood (b) support vector machine (SVM) (c) mahalanobis distance.

Figure 8 shows a separate analysis of classifier algorithm accuracy in pothole classification. 3 classifiers were used with 15 types of band combinations in classification. The maximum likelihood and Mahalanobis distance showed a small error with double band classification, which is averagely <0.3m<sup>2</sup>. Double band classification indicated a small error especially for green + red edge band, green + red band, and NIR + red edge band combination. SVM shows the largest error for almost band classification combination, the error achieves 1m<sup>2</sup> that almost the same area of the pothole sample, thus it is an algorithm which not suitable for pothole detection. However quad band and triple band classification achieve as low as 0.6m<sup>2</sup>.

Based on the triple band classification with mahalanobis distance and maximum likelihood, NIR + red edge + red band combination and green + red edge + red band combination showed the lowest error <0.2m<sup>2</sup>. While, quad band classification (green + NIR + red edge + red) achieves <0.4m<sup>2</sup> with maximum likelihood, SVM and mahalanobis distance. All single band classification (green, NIR, red edge and red) layers failed to detect a pothole with offered classifier algorithm in this study (maximum likelihood, SVM and mahalanobis distance). Hence, the error of detected potholes is high.

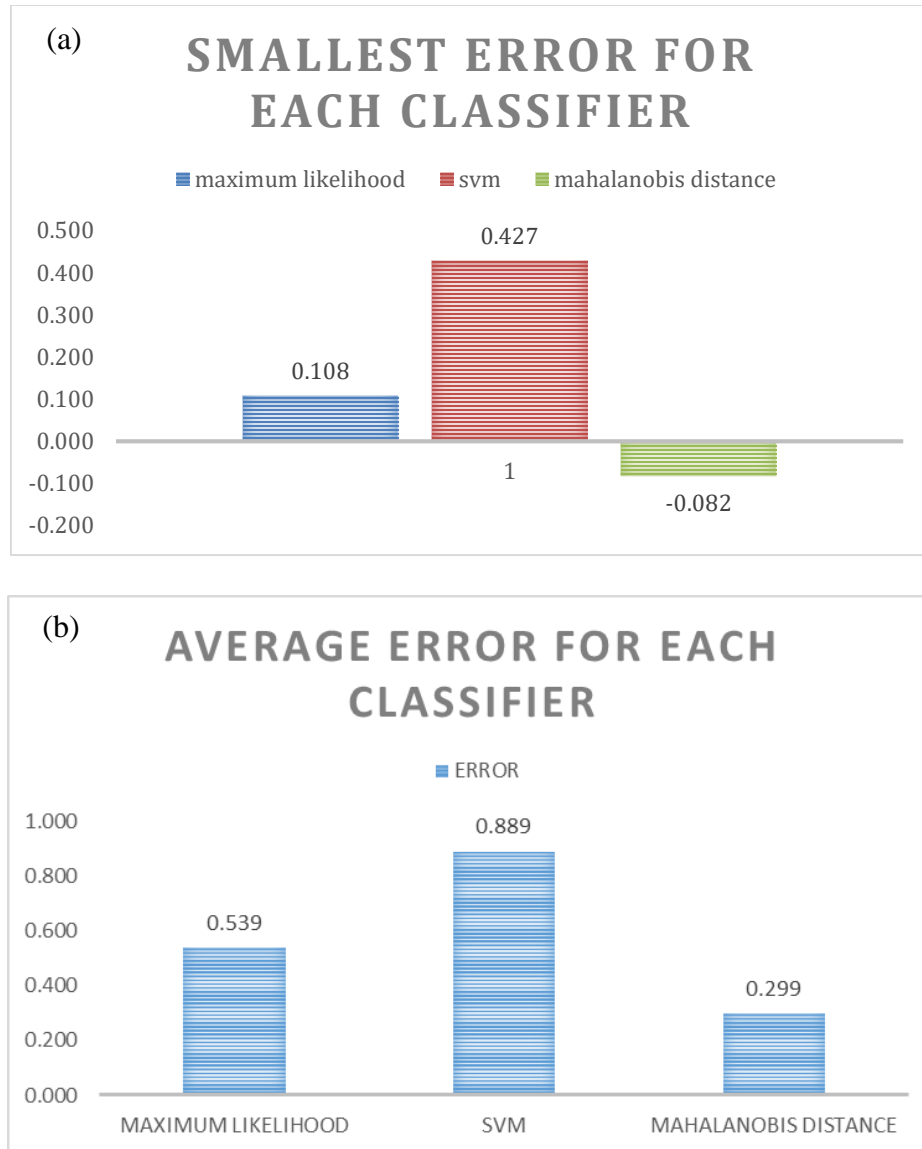
**Figure 9.** (a) Smallest error for each classifier (b) average error for each classifier.

Figure 9(a) shows the smallest error yield from the classifier algorithm used and Figure 9(b) shows an average of error yield from the classifier algorithm used. Classifier algorithm maximum likelihood gives a lowest error  $0.108\text{m}^2$  with a combination of NIR + red edge band. SVM gives the lowest error of  $0.427\text{m}^2$  with a combination of green + NIR + red edge + red band. While Mahalanobis distance gives the lowest error of  $-0.082\text{m}^2$  with a combination of red edge + red band. Averagely, Mahalanobis distance gives the lowest error of  $0.299\text{m}^2$  of all band used. Rank second, maximum likelihood with an accuracy of  $0.539\text{m}^2$  and SVM with an accuracy of  $0.889\text{m}^2$ .
