The hazards of coastal erosion in Central Java, Indonesia: An overview

Muh Aris Marfai¹

¹Geography Faculty, Gadjah Mada University, Bulaksumur 55281, Yogyakarta, Indonesia

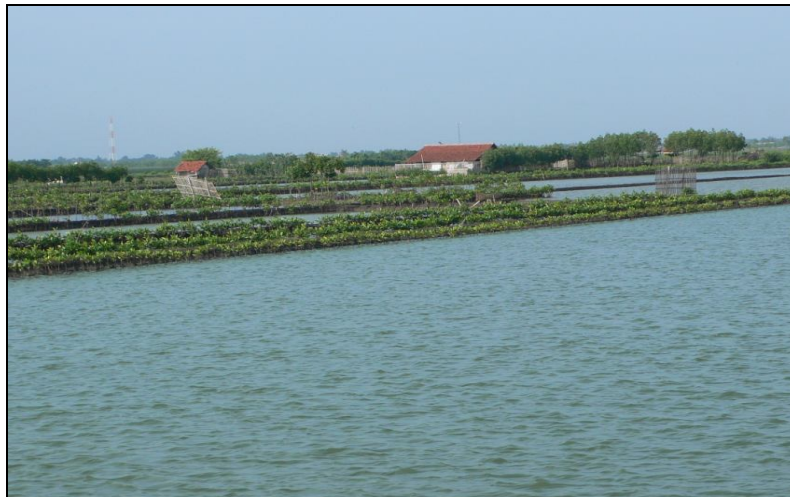
Figure 5. Coastal erosion leading to loss of land and permanent inundation in Tegal

Intensive erosion process took place along the coastal area of Tegal. According to Yudono (2008), erosion occurred up to 250 m towards the land. This posed a threat to the coastal community in the form of land loss and damage to coastal settlements. Figure 5 exposed the impact of the erosion along the Tegal coastal area. This is in line with the report of the Board of the Environmental impact monitoring / Bapedalda (2002) which put the loss of land due to coastal erosion along the northern coastline at 2,910 hectares in the last five years.

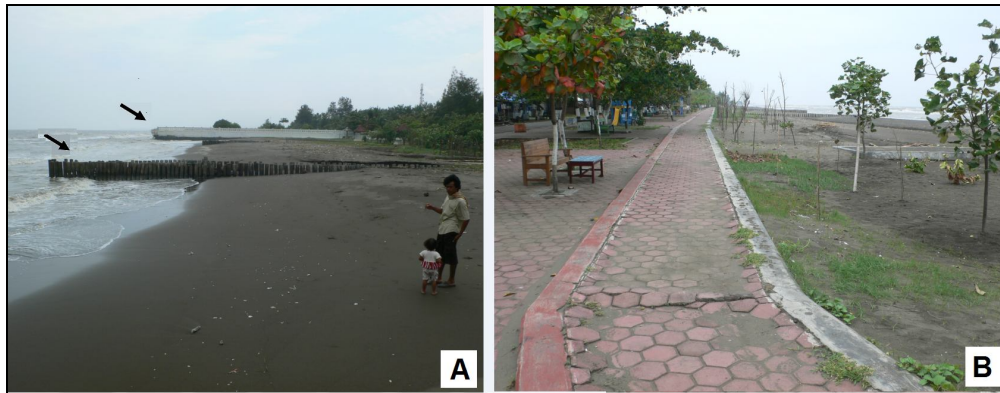
Figure 6. Structure measure/groyne (A) and protected coastal area for tourism activity (B)

Coastal community in Tegal responded to the erosion problems by mangrove re-forestation and constructing structures such as ripraps, seawalls, jetties and groins. The groins, which the local government built in 2001, had been quite effective in reducing erosion at certain points along the coastline. They had also turned the area into a tourist attraction (Figure 6). Apart from that, forest (mangrove) rehabilitation would go a long way to reduce the erosion threat while producing food for the fish through the photosynthesis of organic matter .

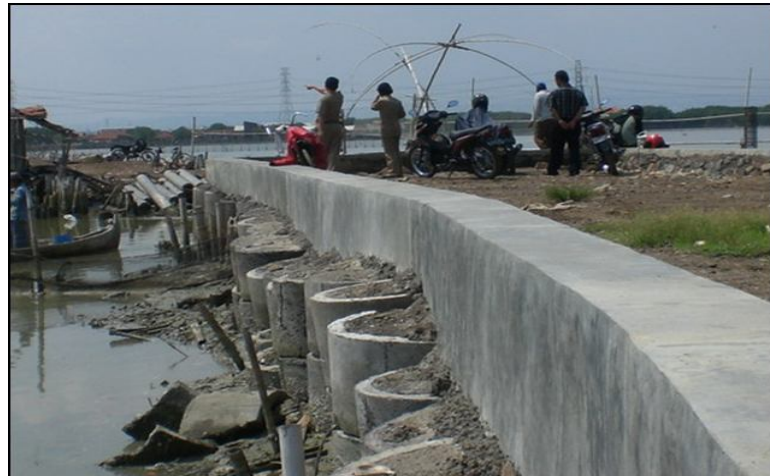
Figure 8. Structural coastal defense in Demak

Local government had strengthened the coordination among governmental agencies to cope with the issue of coastal erosion. Environment Affairs Office of Demak Regency (Kantor Lingkungan Hidup/KLH), Ministry of Marine Affairs and Fisheries Republic of Indonesia (Kementrian Kelautan dan Perikanan), and the Ministry of Agriculture Republic of Indonesia (Kementrian Pertanian) are involve on the coastal mitigation action against erosion process. Local government had also built the dike along the coastal area to block the tide and wave action (Figure 8).
